## Ultrasound Imaging in a Case of Urethral Diverticulum

Ching-Chung Liang, M.D.

Department of Obstetrics and Gynecology, Chang Gung Memorial Hospital, Linkou Medical Center and College of Medicine, Chang Gung University, Taoyuan, Taiwan; E-mail: ccjoliang@cgmh.org.tw

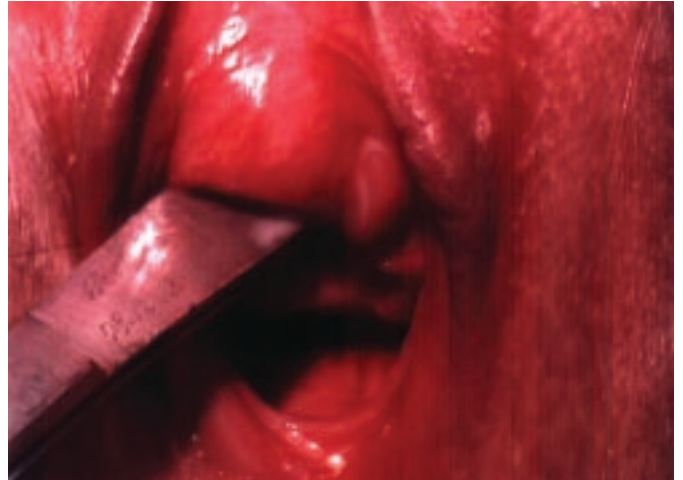
**Fig. 1.** Pressure upon the suburethral mass resulted in expulsion of a little pus from the urethra.

A 34-year-old woman, gravida 3, para 2, was transferred to our urogynecological clinic for further investigation because of a 2-year history of frequency, urgency and occasional dysuria. General physical examination was unremarkable. Pelvic examination showed a 3 cm non-tender, firm and poorly mobile mass palpable in the anterior vaginal wall. Pressure upon the mass resulted in expulsion of a little pus from the urethra (Fig. 1).

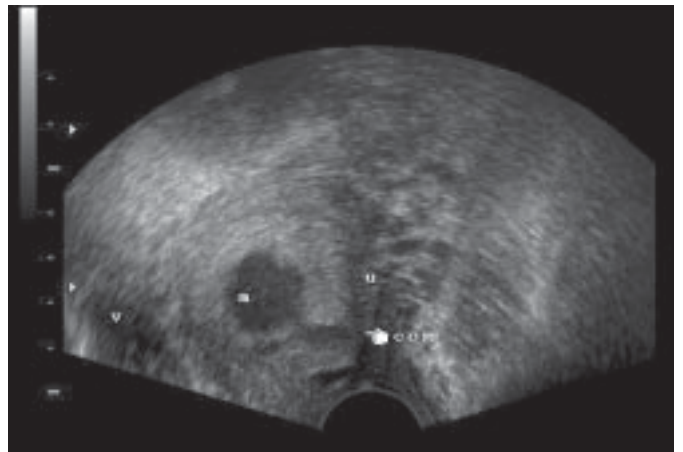
**Fig. 2.** Introital sonography demonstrating a diverticular opening in the distal urethra. u: urethra; com: communicating opening; m: mass; v: vagina.

The presence of a suburethral vaginal mass was further evaluated by performing introital sonography using an Aloka SSD-1200 scanner (Tokyo, Japan) with a 3.5 MHz small curved linear-array transducer. It showed a communicating opening between the urethra and suburethral mass (Fig. 2). The patient underwent a diverticulectomy and has been well postoperatively.

Ultrasound has been used in the detection of urethral diverticula because of its advantages of being non-invasive and readily available in most urological and gynecological units. Multiple approaches to ultrasonography have been employed including transvaginal, translabial, suprapubic, perineal and transrectal. When a tiny diverticular opening in the distal urethra cannot be detected by endoscopy, ultrasound might enable visualization. Keefe et al supported transperineal or transvaginal sonography, stating 100% sensitivity in their small series of urethral diverticula [2]. However, the result of our case shows that a transintroital approach seems more appropriate than other ultrasonography to detect diverticula in the distal urethra.
